LABORATORY AND FIELD INVESTIGATIONS
EXAMINING
THE INHIBITION OF
ACID GENERATION FROM PYRITIC MATERIALS

PERD COAL WASTE ROCK PILES
FIELD OBSERVATIONS AND REPORT

Fred Baechler

RE: Investigation of Perd Piles at CBDC's VJCPP

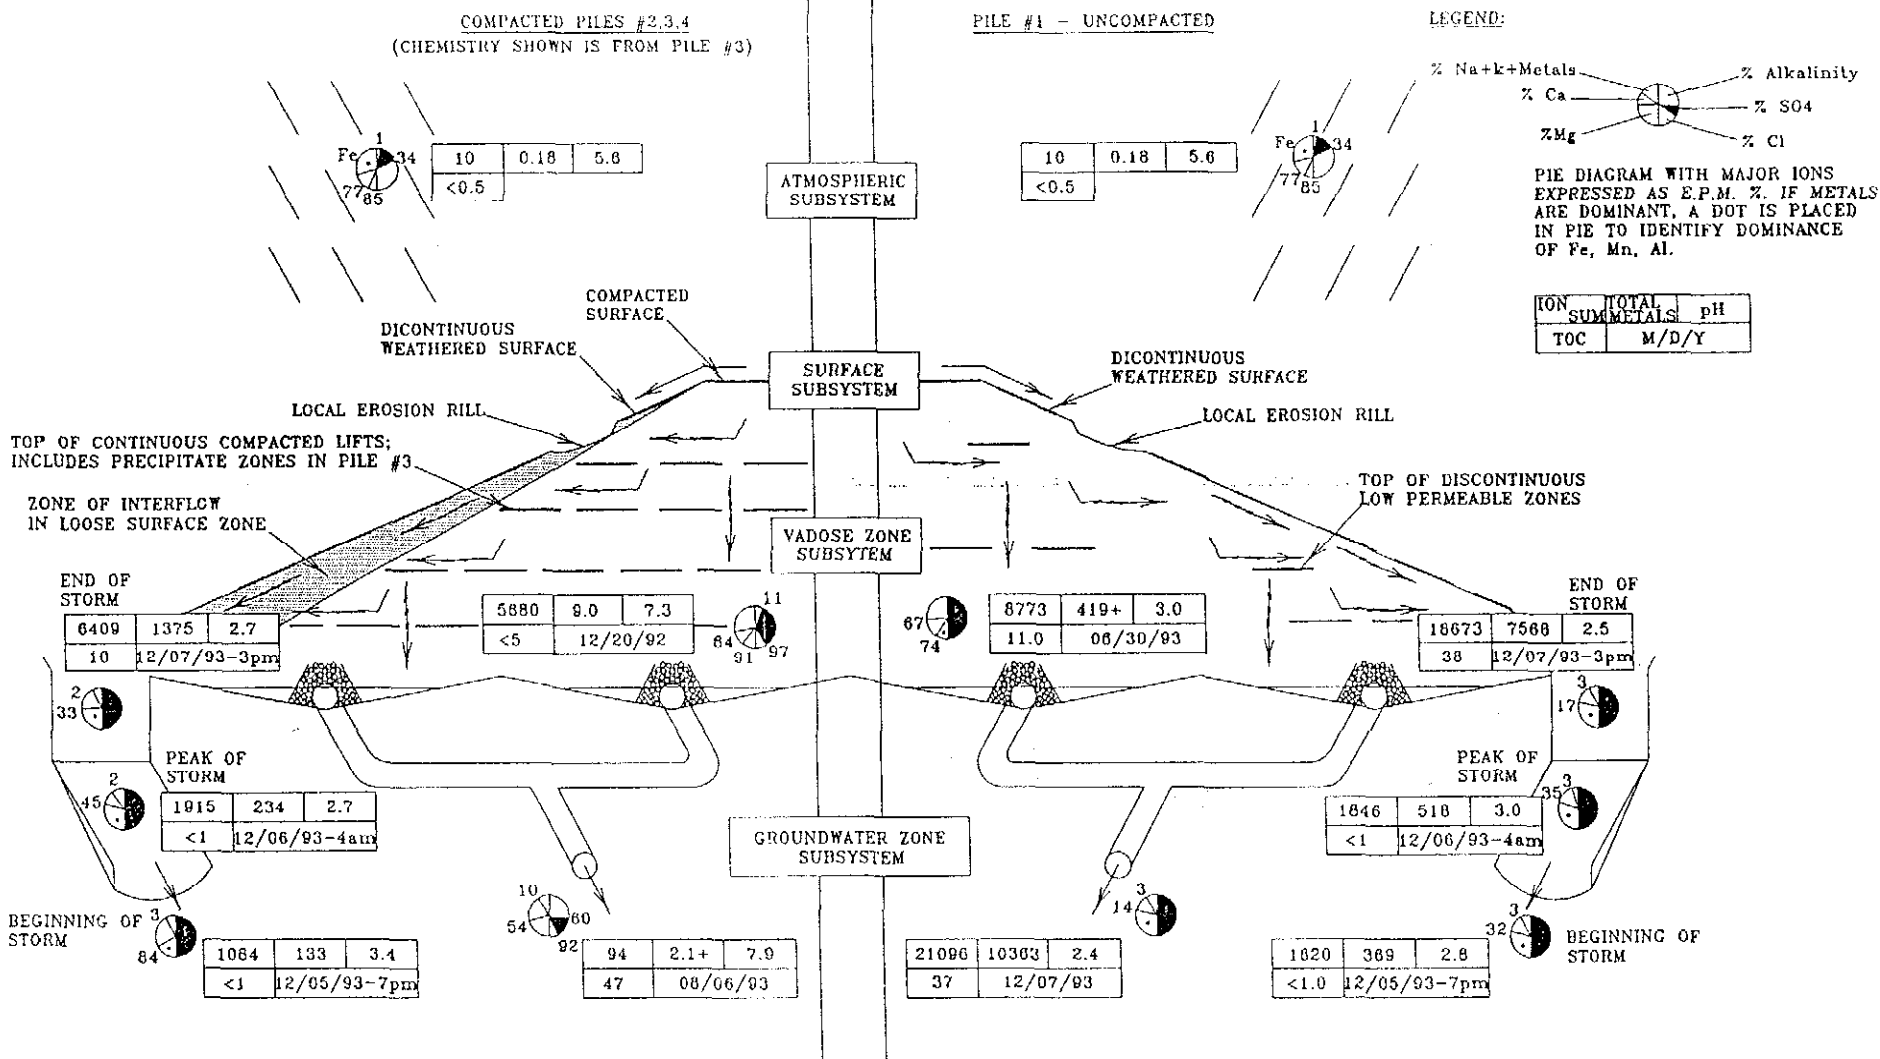
FIGURE 1
CONCEPTUAL/ANALYTICAL MODEL OF THE
HYDROGEOLOGICAL AND GEOCHEMICAL CYCLES
WITHIN THE TEST PILES
(REFINEMENT #2, FEB/93)

The observations have been compared with what was predicted from the monitoring program. That prediction was presented in the PERD report in the form of a conceptual model of flow and chemistry within the pile. It has been reproduced here in Figure 1.

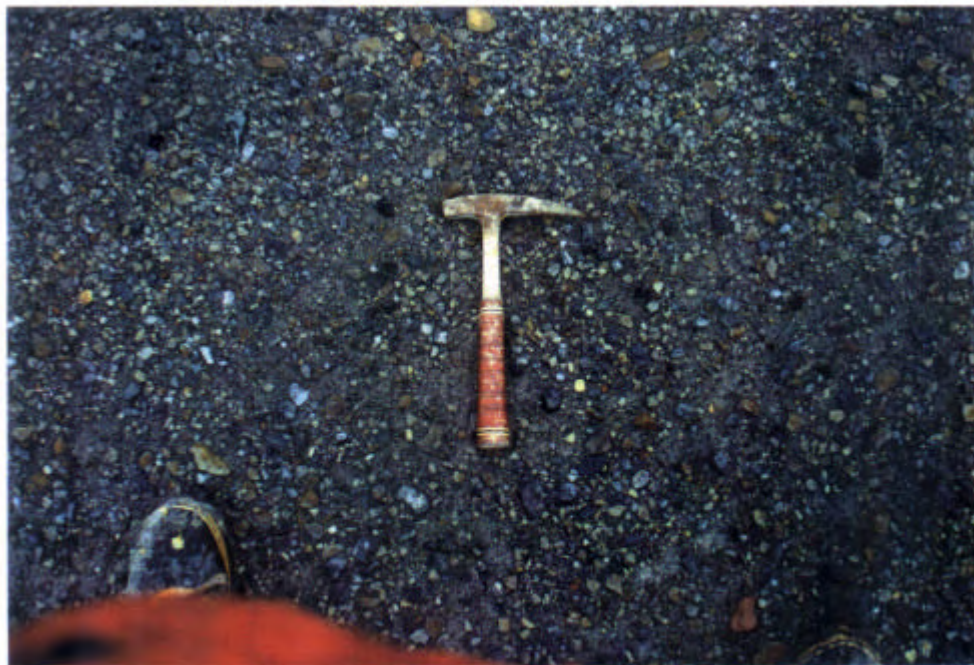
Plate 3: PERD Pile 1, Uncompacted, No Amendment, November 11-13, 1996. Lag pavement over surface.

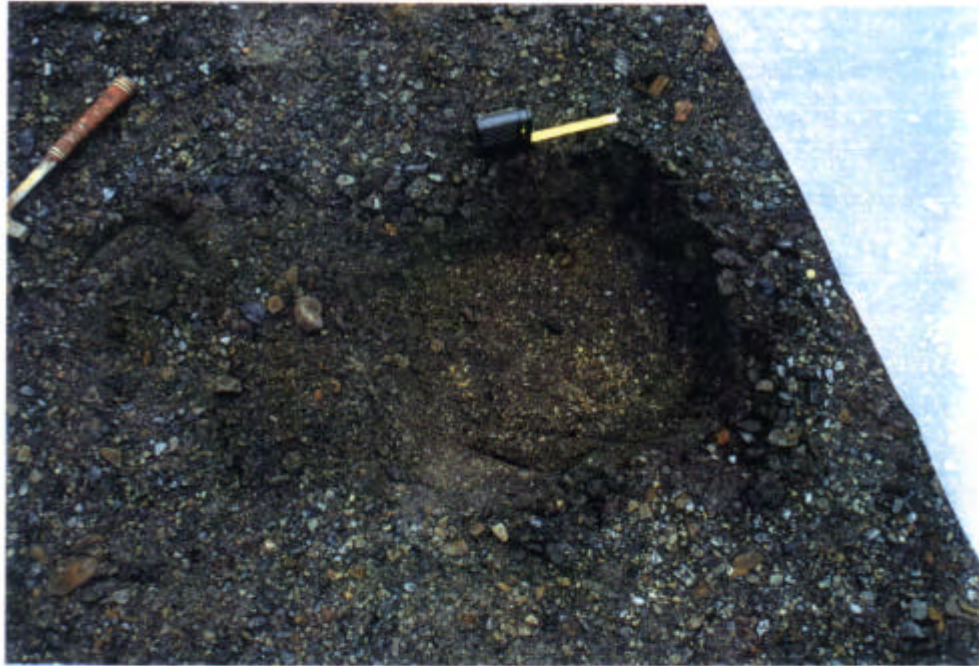
Plate 4: PERD Pile 1, Uncompacted, No Amendment, November 11-13, 1996.
First pit surface layers.

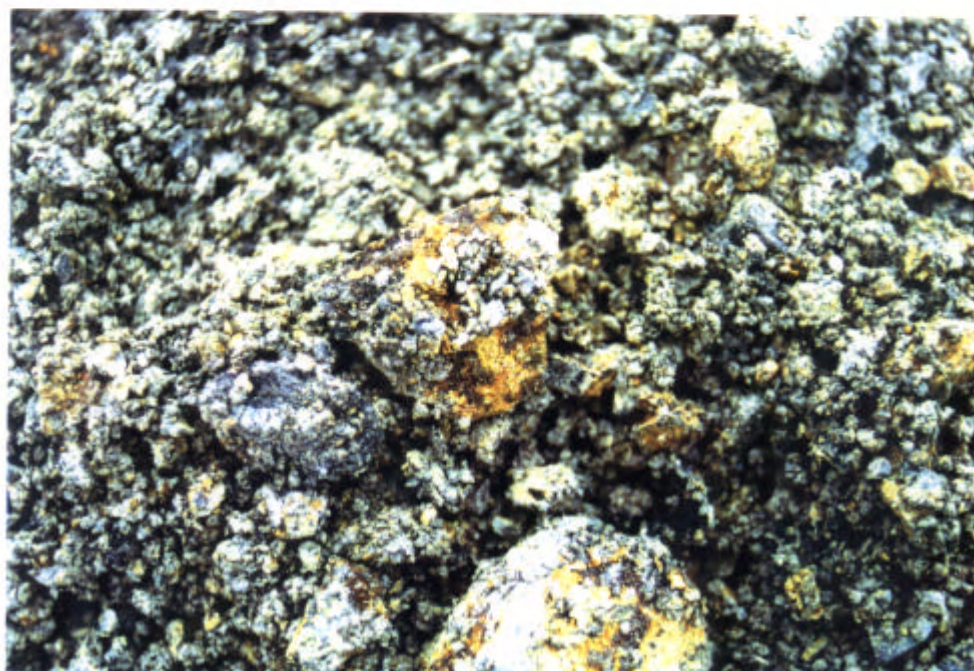
Plate 9: PERD Pile 1, Uncompacted, No Amendment, November 11-13, 1996.
Staining on clasts out of pit 1.

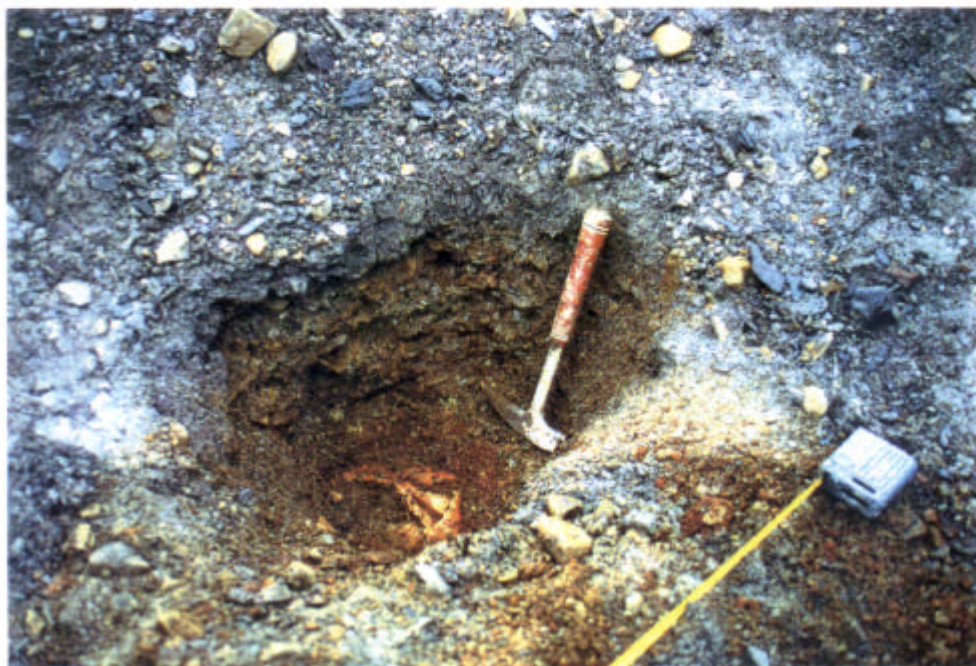
At the toe-of-slope one pit positioned along the east side wall noted a 5 cm thick "dark red" (dark reddish brown 10R3/4 to very dark red 5R2/6) precipitate zone developed in the underlying till immediately over the plastic liner keyed into the side wall, that underlies the surface perimeter drain. At the northeast corner, where seepage had been noted during rainfall events, a loose 4-8 cm thick heavily "yellow" stained zone was noted in the coarse waste directly over the till liner; a hardpan was not developed.

Plate 17: PERD Pile 1, Uncompacted, No Amendment, November 11-13, 1996.
Toe of slope pit close-up. Note staining over vapour barrier.

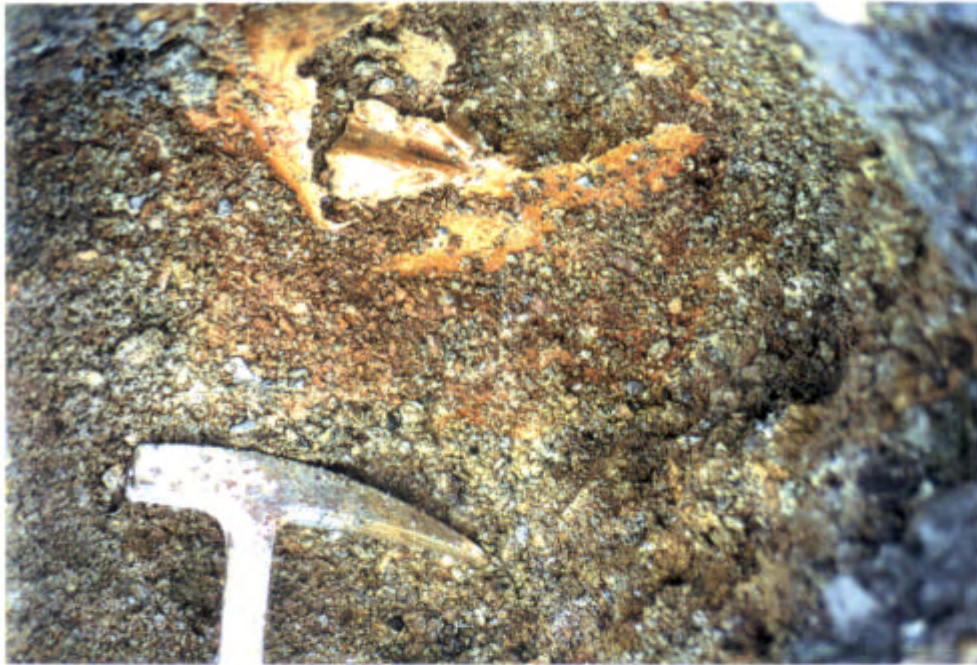
Plate 18: PERD Pile 1, Uncompacted, No Amendment, November 11-13, 1996.
Toe of slope pit. Close-up of staining over vapour barrier.

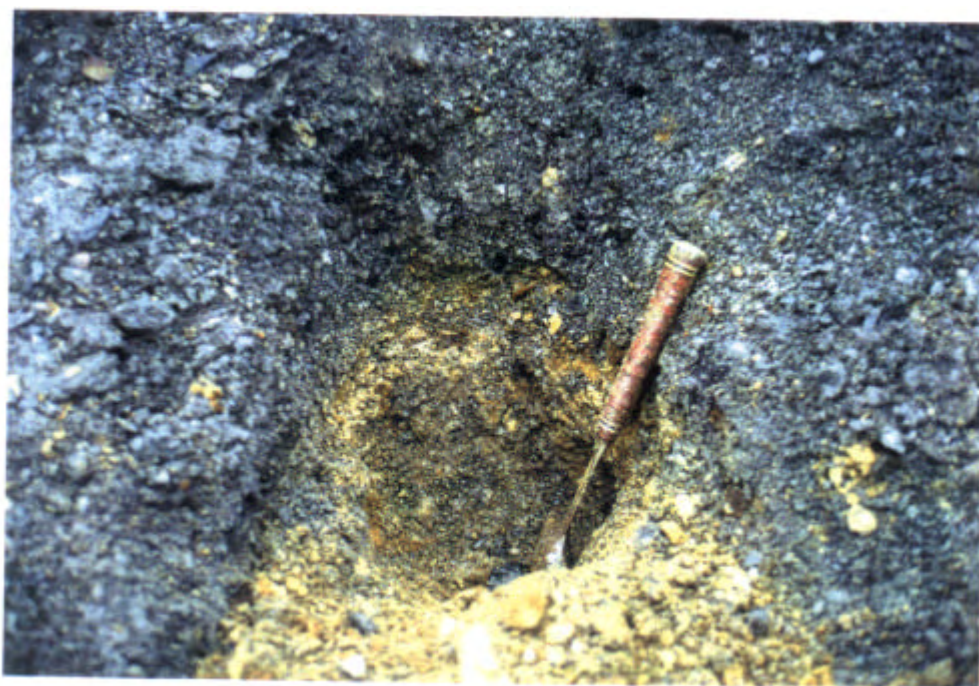
Plate 20: PERD Pile 1, Uncompacted, No Amendment, November 11-13, 1996.
Toe of slope pit at N-E corner. Close-up of staining.

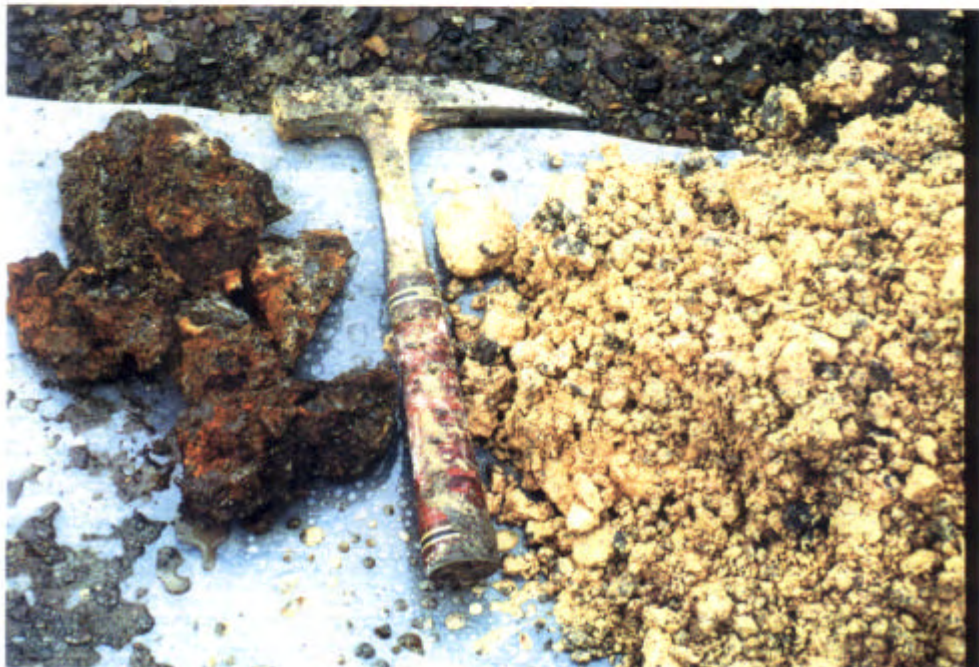
- *Test Pit on Top of the Pile:*
One 0.3 x 0.6 m pit was excavated by hand to a depth of approximately 0.7 m (25% of the total depth of the pile). From the surface down to the top of the first limestone layer (approximately 0.1-0.2 m) was loose weathered, "grey" coarse waste, as noted in Piles 1 and 4; although clasts did not exhibit the precipitate layers. Most of the first limestone layer (0.1 m thick) had been converted to a "dark red brown" hardpan, that when broken came to the surface in cemented blocks. This colour was quantified as very dark red (5R2/6) to very dusky red (10R2/2). The pan was difficult to dig through and was dry; some unaltered limestone was sporadically present under the hardpan which had not been altered as yet. There was no evidence of staining in the coarse waste immediately above the hardpan that would indicate a perched water table.

Plate 28: PERD Pile 3, Compacted, Limestone Amended, November 11-13, 1996.
Pit, top of pile. First limestone layer hardpan.

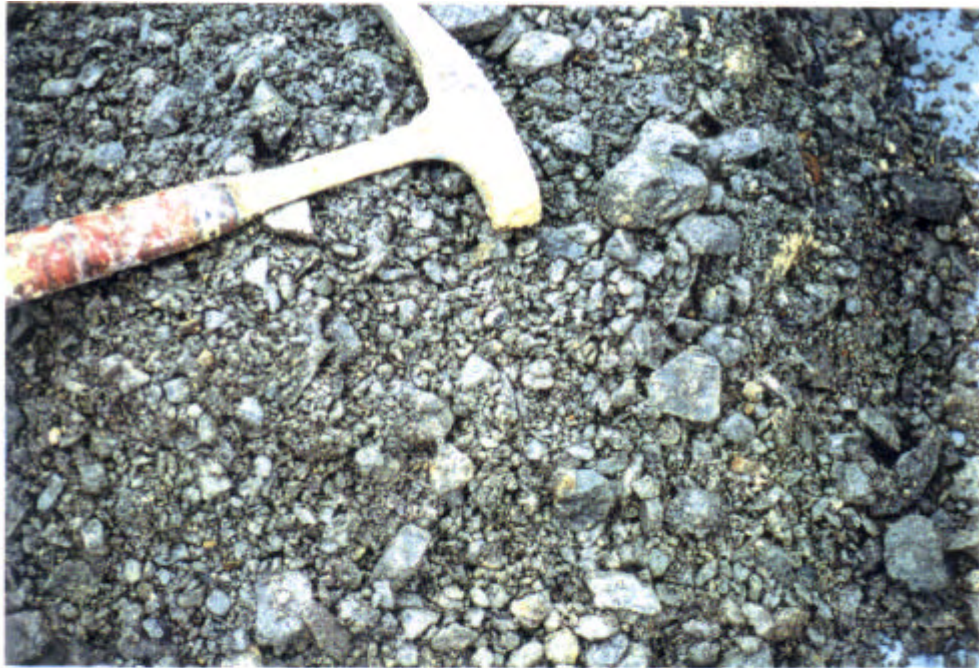
Beneath the hardpan (from 0.3-0.5 m below surface) was fresh, "black" (dark grey N3 to black N1), compact, dry, coarse waste. The clasts showed no evidence of staining on the surface. It appeared that the hardpan produced a sufficiently low enough permeability to significantly reduce moisture infiltration below it. This was further exemplified when the next limestone layer was encountered. Its 0.1 m thickness was comprised solely of

Plate 29: PERD Pile 3, Compacted, Limestone Amended, November 11-13, 1996. Pit, top of pile. Fresh coarse coal waste below limestone hardpan.

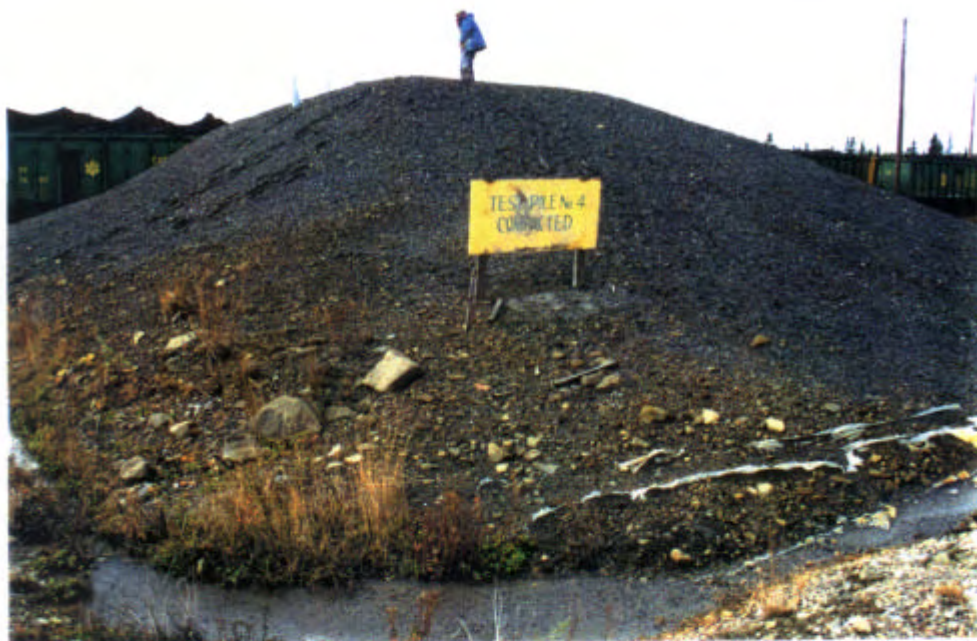
Plate 38: PERD Pile 4, Compacted, No Amendment, November 11-13, 1996. S-W corner. Note staining in foreground.

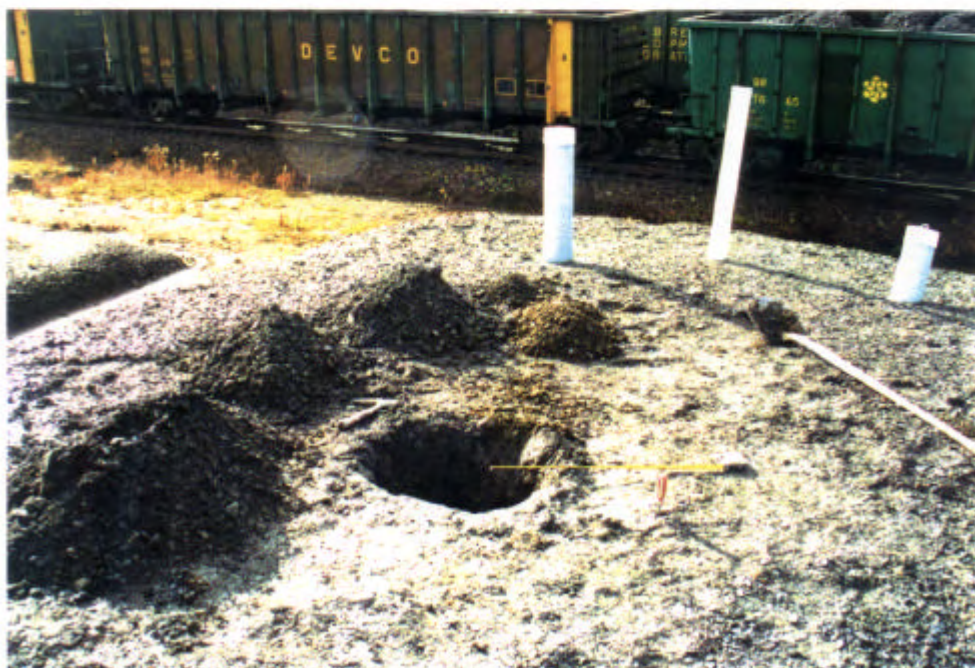
- *Test Pit on Top of the Pile:*
One 0.3 x 0.6 m pit was excavated by hand to a depth of approximately 0.9 m (25% of the total depth of the pile). From the surface down to a depth of 0.75 m the coarse waste was no longer compacted and exhibited the same "grey" conditions as found in Pile 1. A zone of heavy "yellow" precipitate was encountered from 0.75 to at least the base of the hole. When excavated the material came up loose (not in cemented fragments). There was no staining zone noticed in the coarse waste above the precipitate zone.

Plate 39: PERD Pile 4, Compacted, No Amendment, November 11-13, 1996. Pit excavated on top.

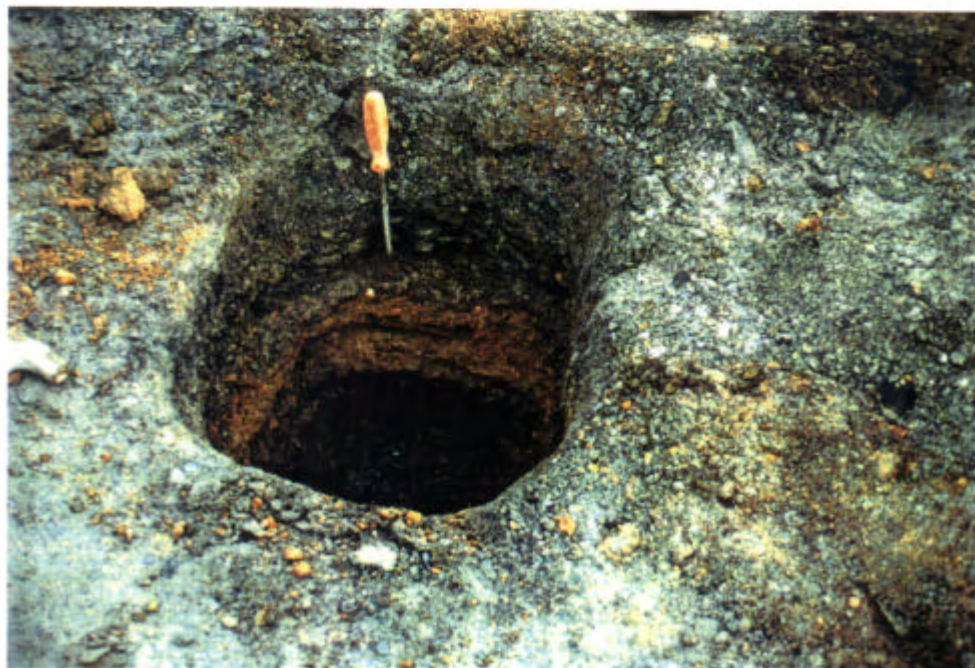
- *Test Pit on Top of the Pile:*
Two 0.3 x 0.6 m pits were excavated by hand in the surface depression to a depth of 0.3 m (10% of the total depth of the pile). The surface lag pavement was obscured by deposition of fines over the center of the depression. Both pits exhibited similar conditions. From the surface, down to the top of the phosphate layer, (approximately 0.2 m) was loose, weathered, "grey" coarse waste as noted in Piles 1 and 4. There was evidence of slight "yellow" mottling immediately above the phosphate hardpan layer indicating possible ephemeral perched conditions. Most of the phosphate layer had been turned into a very strong, "orange brown" hardpan, approximately 2-3 cm thick; which came to the surface as cemented blocks. This colour ranged from dark yellowish orange (10YR6/6) to moderate yellowish brown (10YR5/4). The natural phosphate sand was a light brown (5YR5/6). The pan was difficult to dig through and was dry; some phosphate sand was sporadically present under the hardpan which had not been altered as yet. The hardpan was underlain by relatively fresh, black, compacted, coarse, waste rock.

Plate 53: PERD Pile 5, Compacted, Phosphate Amended, November 11-13, 1996.
First pit on top. Phosphate hardpan layer.

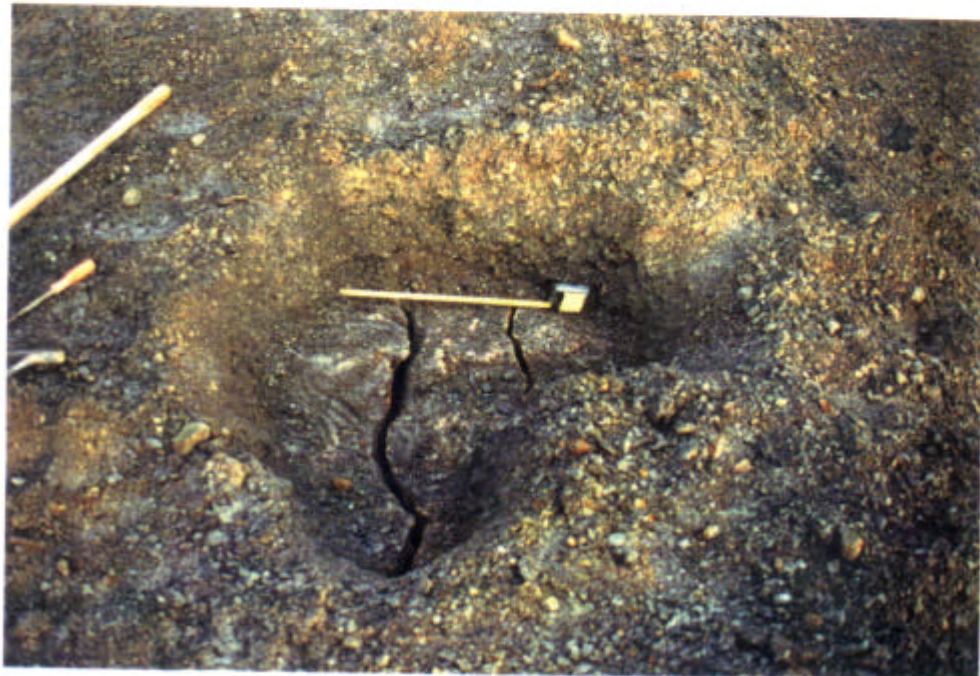
This suggests that after hardening tension cracks formed from the weight of the down slope portion of the hardpan. Although the depth of phosphate allowed the crack to self-heal, the layer eventually ran out and the crack dissected the entire hardpan allowing water and air to permeate into the core of the pile. However, the pit excavated into the shoulder at the southeast corner where the major rill was present, revealed no cracks in the hardpan.

Plate 61: PERD Pile 5, Compacted, Phosphate Amended, November 11-13, 1996.
Exposed hardpan layer with cracks in extended second pit on top shoulder.

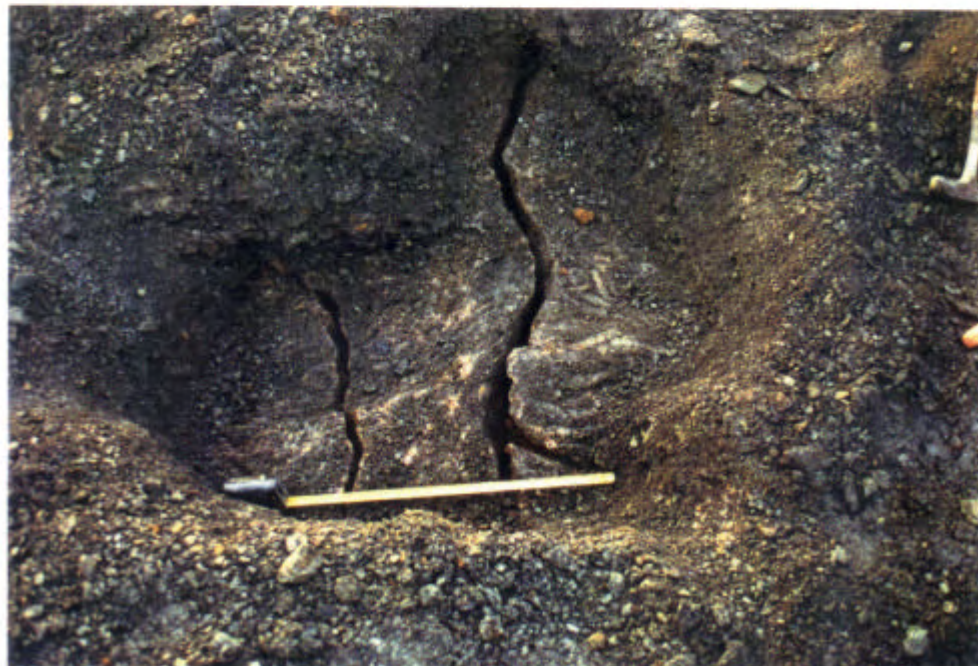
Plate 63: PERD Pile 5, Compacted, Phosphate Amended, November 11-13, 1996. Exposed hardpan layer with cracks in extended second pit on top shoulder.

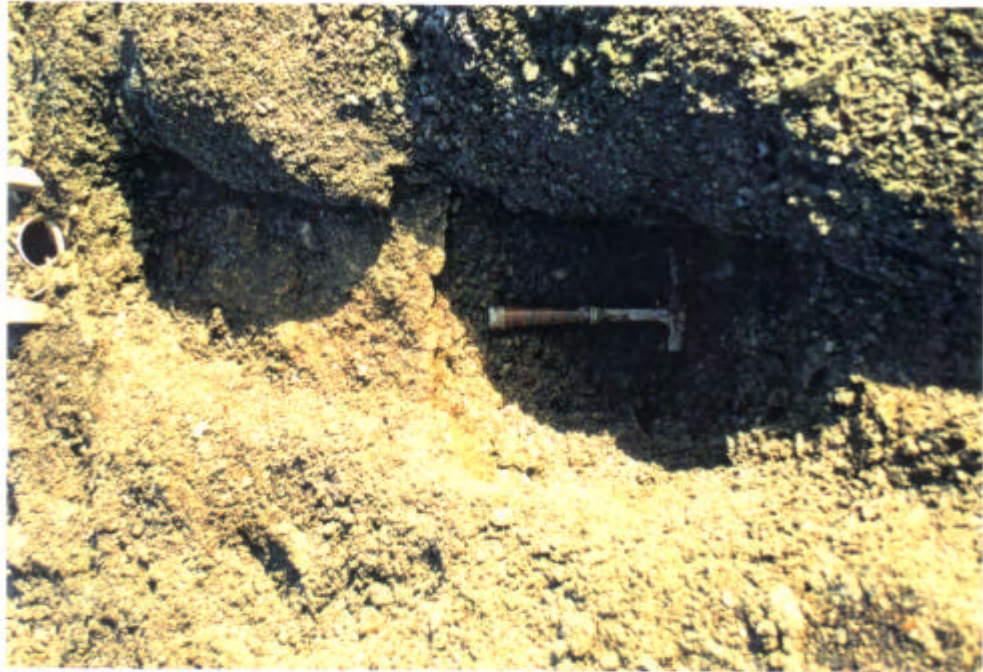
Three trenches were excavated down the side slopes, two on the side slopes and one at the southeast corner which followed the gully downslope. All trenches indicated that the phosphate layer was not constructed over the lower third of the slope. It is thought that this was due to construction problems in placing the material over the steeper lower slopes, required to squeeze Pile 5 into the only space left available. Since the hardpan would not have been properly seated at the toe of the slope, the weight of the hardpan over the slope could have created the tension cracks noted.

Plate 70: PERD Pile 5, Compacted, Phosphate Amended, November 11-13, 1996.
Base of west side trench showing end of phosphate hardpan layer.

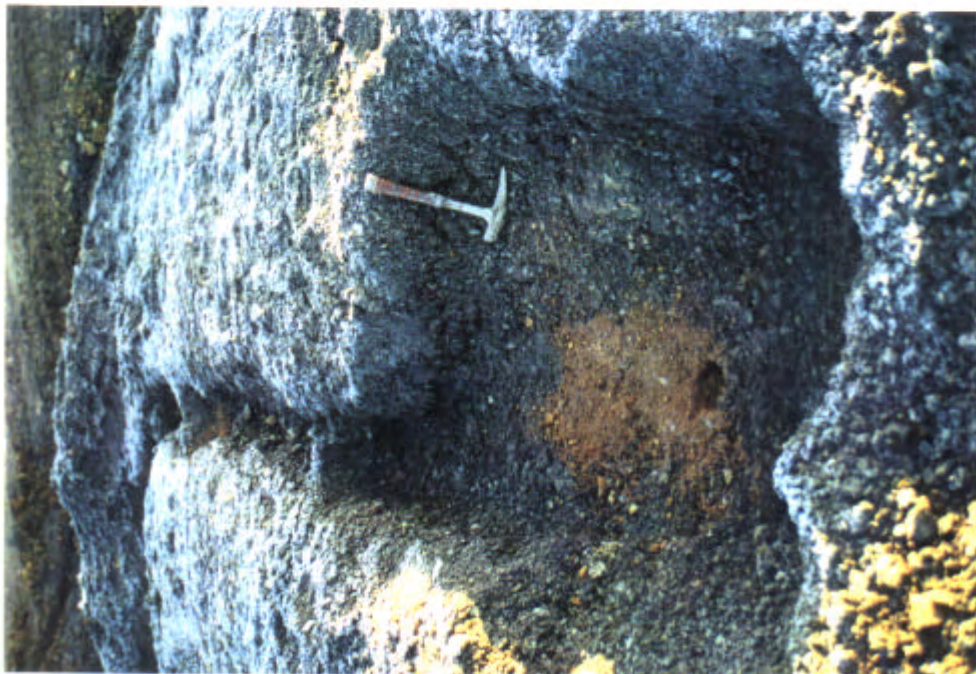
The hardpan did control the depth of gullying by creating an essentially non-erodible base. In this area the surface of the hardpan was smooth; there were no cracks noticeable all the way down the slope.

Plate 75: PERD Pile 5, Compacted, Phosphate Amended, November 11-13, 1996. Third pit excavated under natural rill on east side on pile. Note absence of cracks.

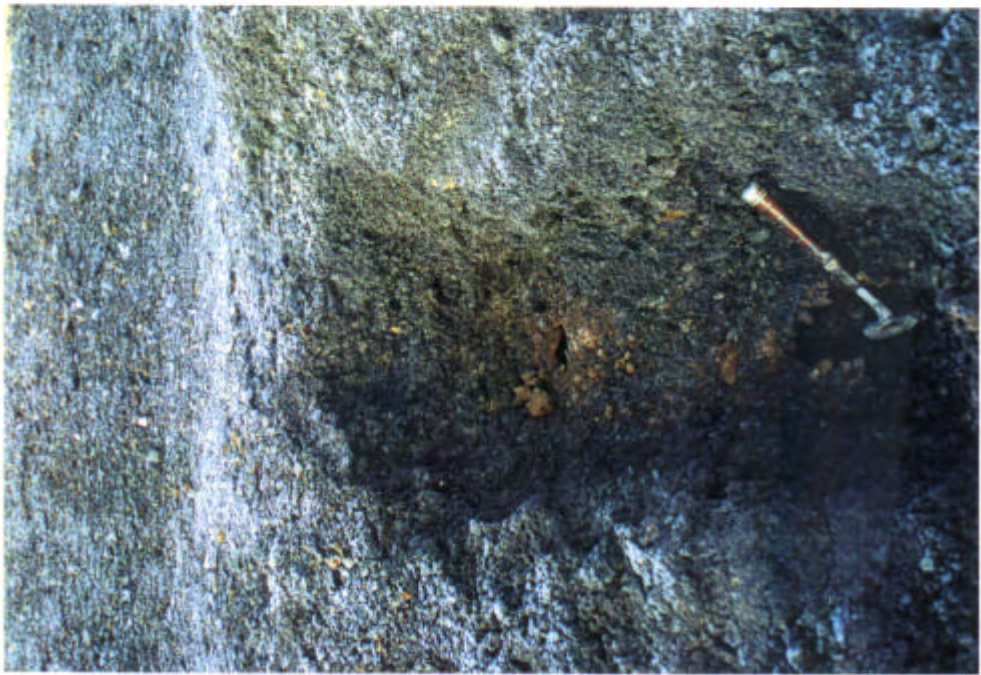
Plate 79: PERD Pile 5, Compacted, Phosphate Amended, November 11-13, 1996.
Excavation on south side of pile exposing limit of phosphate hardpan.
